## PRELIMINARY ASSESSMENT

# Atka Air Force Auxiliary Field Site Atka, Alaska

January 23, 2002

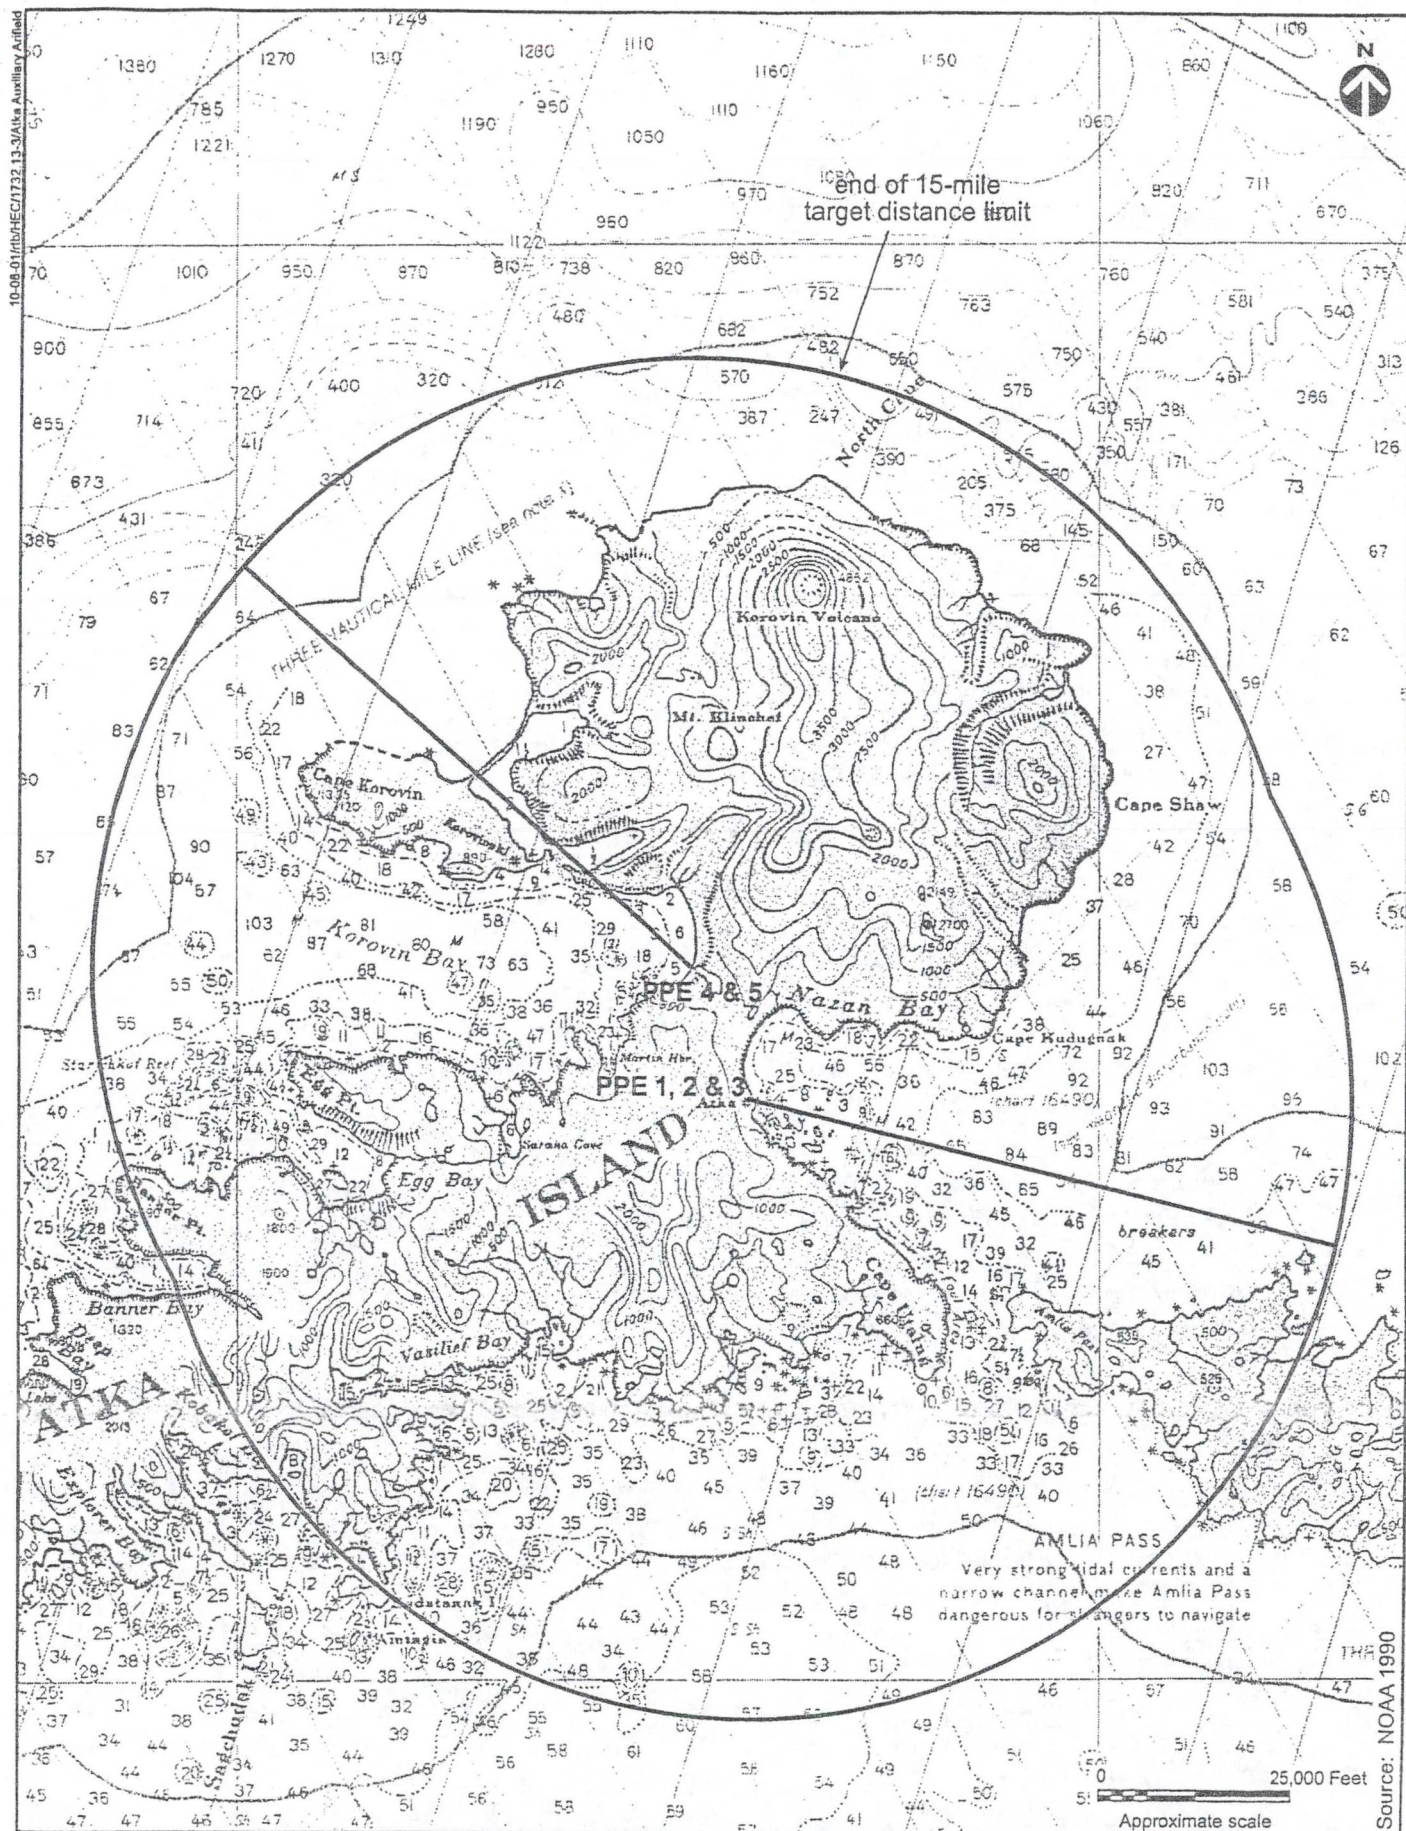
Figure 3-2. Fifteen-mile target distance limit map, Atka Air Force Auxiliary Field site, Atka, Alaska.

Multiple Probable Points of Entry (PPE) exist at the site (Figures 2-2 and 3-2). PPE1 is located in Puganax Creek, approximately 50 feet upstream from its confluence with Nazan Bay, where several drums are located in and around the water. The 15-mile target distance limit (TDL) associated with PPE1 begins at this point, extends approximately 50 feet downstream into Nazan Bay, and then continues 15 miles into the bay. PPE2 is located at the confluence of an unnamed creek and Nazan Bay, on the western side of the airfield downstream of Disposal Site C. The TDL associated with PPE2 extends 15 miles into Nazan Bay. PPE3 is located in Dock Creek approximately 100 yards upstream of its confluence with Nazan Bay. It is reported that a

military disposal site may be located in this area (USACE 1999). The TDL associated with PPE3 begins at this point, extends approximately 100 yards to Nazan Bay, and then continues 15 miles into Nazan Bay. PPE4 is located approximately 100 yards upstream of Korovin Lake, south of the former hospital complex and Disposal Site A, within an unnamed creek that flows into the lake. The 15-mile TDL follows the unnamed creek into Korovin Lake, extends through an unnamed creek between Korovin Lake and Korovin Bay, and continues the remainder of the 15 miles into Korovin Bay. PPE5 is located at a seep downgradient of Disposal Site A that flows into Korovin Lake, approximately 50 feet west of the unnamed creek. The 15-mile TDL extends approximately 0.5 miles through Korovin Lake, continues through the unnamed creek between Korovin lake and Korovin Bay, and then continues the remainder of the 15 miles into Korovin Bay.
